## DEFINITION

Have you ever encountered a white haze that is easily wiped off a powder coated part after its cured? Formation of this undesirable film on the coating surface is the result of a process called blooming. It primarily occurs in regular durable, TGIC polyester type coatings.

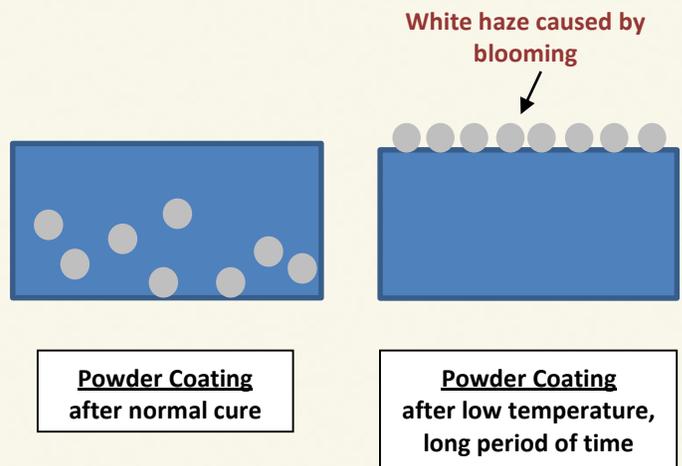
The white haze comes from nonreactive, residual material in the polyester resin. When the cure process proceeds at the designed rate, the material is trapped in the cured film before reaching the surface. If the cure rate is reduced, these materials will have sufficient time to fully bloom and collect on the surface.

- Insufficient oven temperature
- Slow heating, common problem with heavy gage parts
- Uneven heating caused by varying part thickness
- Extended time at low temperature (150° to 320°F)

The hazy film can usually be wiped off with a cloth restoring the desired appearance. However, since blooming occurs at low temperatures, it could indicate parts are under cured. If blooming is observed, parts should be checked for cure. This can be done with an MEK rub test.

It is also recommended that the oven be checked and temperature profile run on parts to ensure oven functioning properly and check the temperature profile of parts measured. Increasing the oven temperature and accelerated cooling of heavy gauge parts after curing can also reduce or eliminate blooming.
